CALSPAN LIMITED ON-SITE AIR BAG DEPLOYMENT INVESTIGATION

CASE NO. 90-19

FLEET - 1990 FORD TAURUS GL STATION WAGON

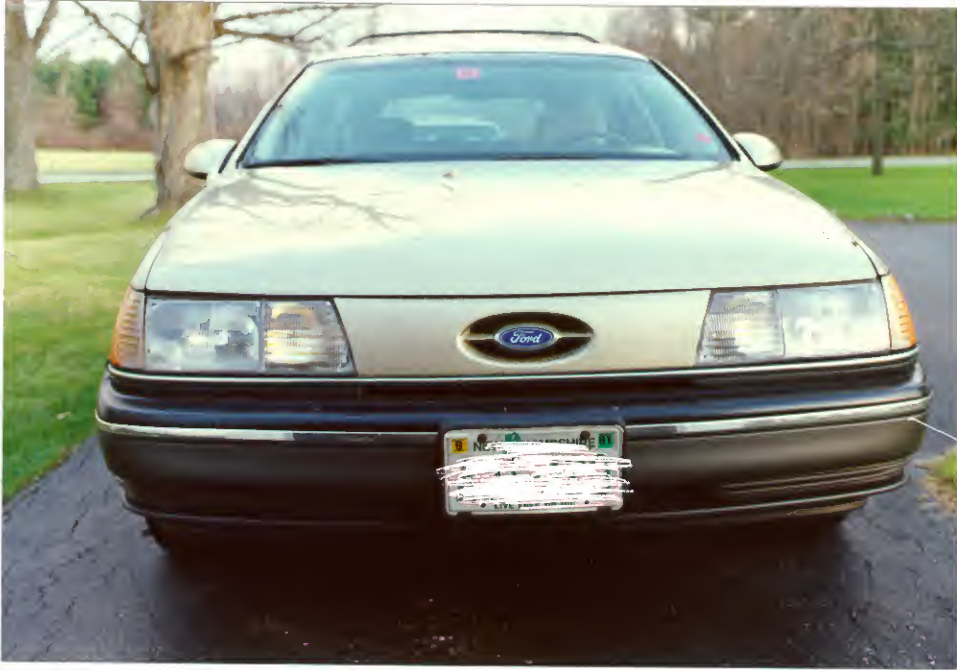
Frontal View Of The Repaired Ford Taurus

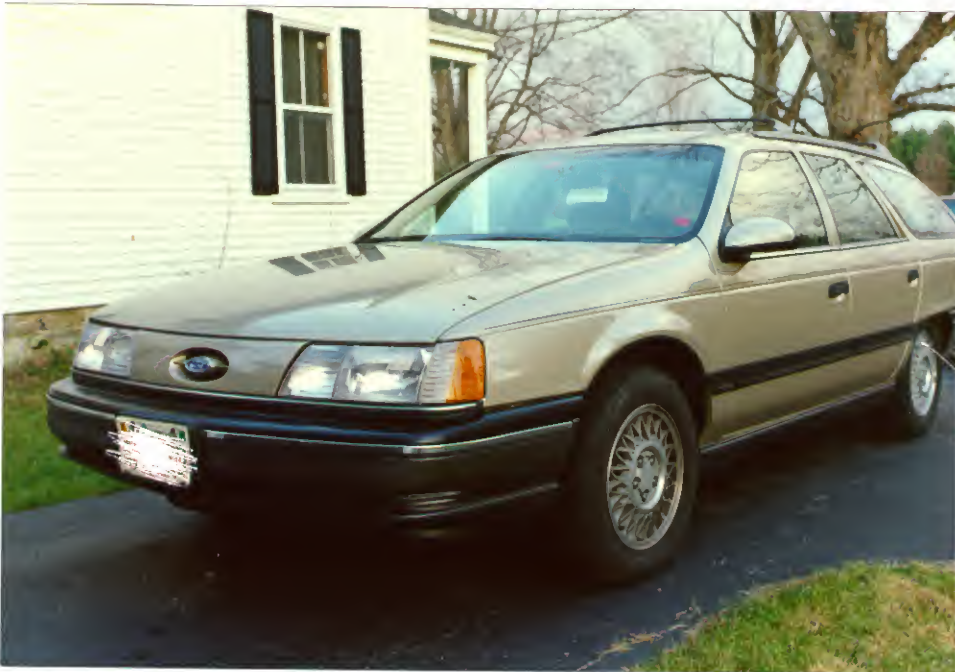
Left Front Three-Quarter View Of The Vehicle

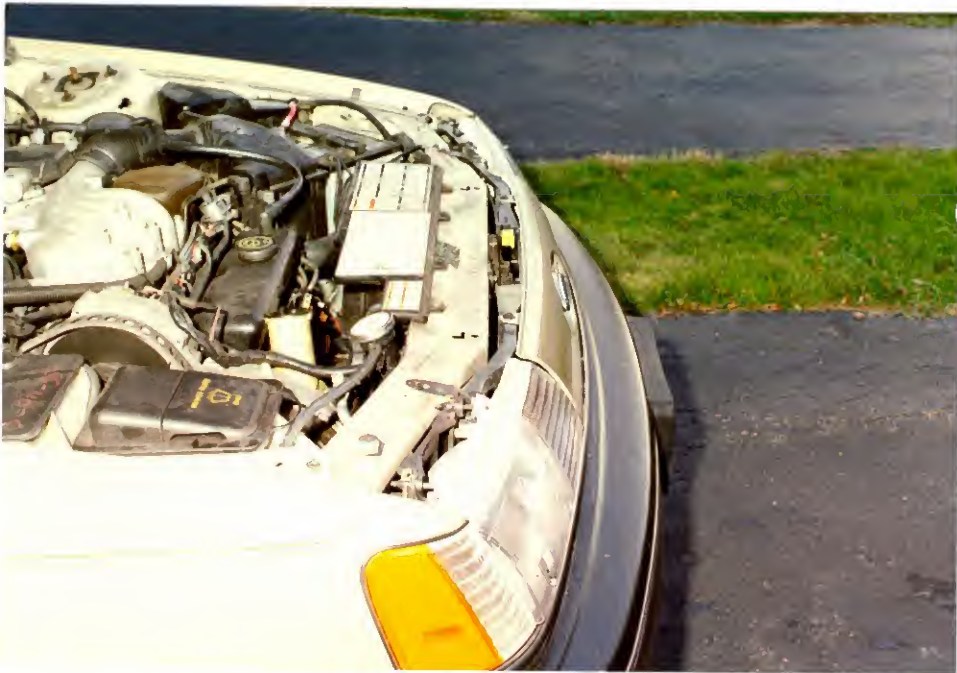
Perpendicular View Across The Radiator Support Panel

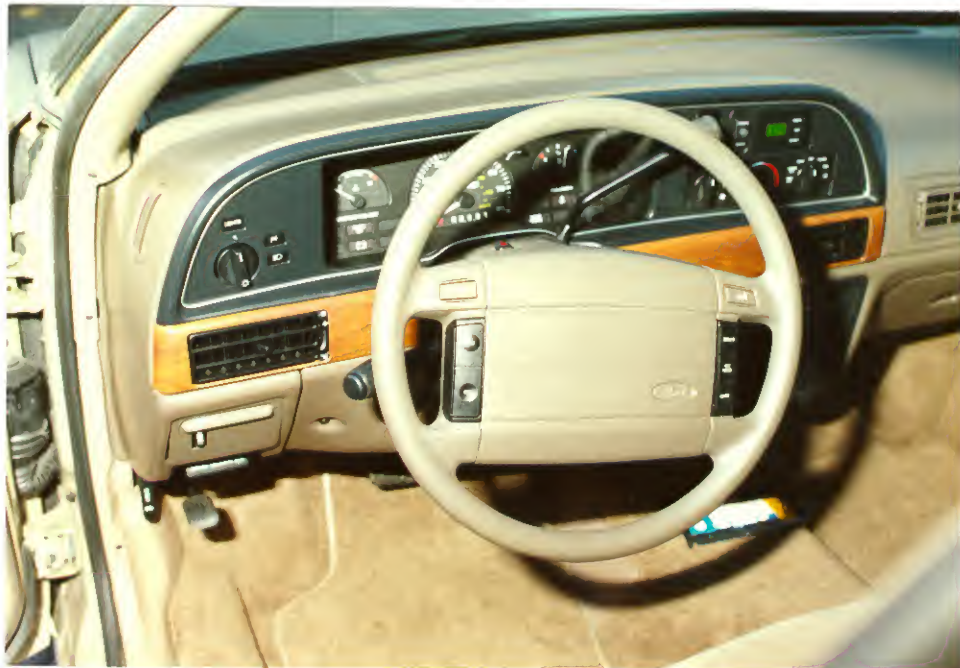
Replaced Driver Air Bag Module

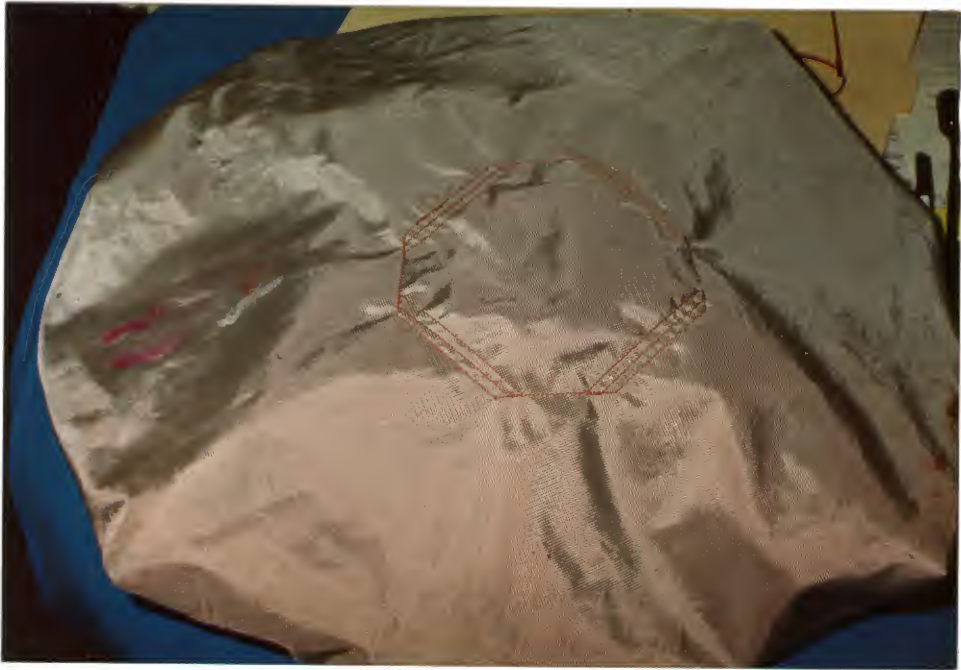
Deployed Driver Air Bag

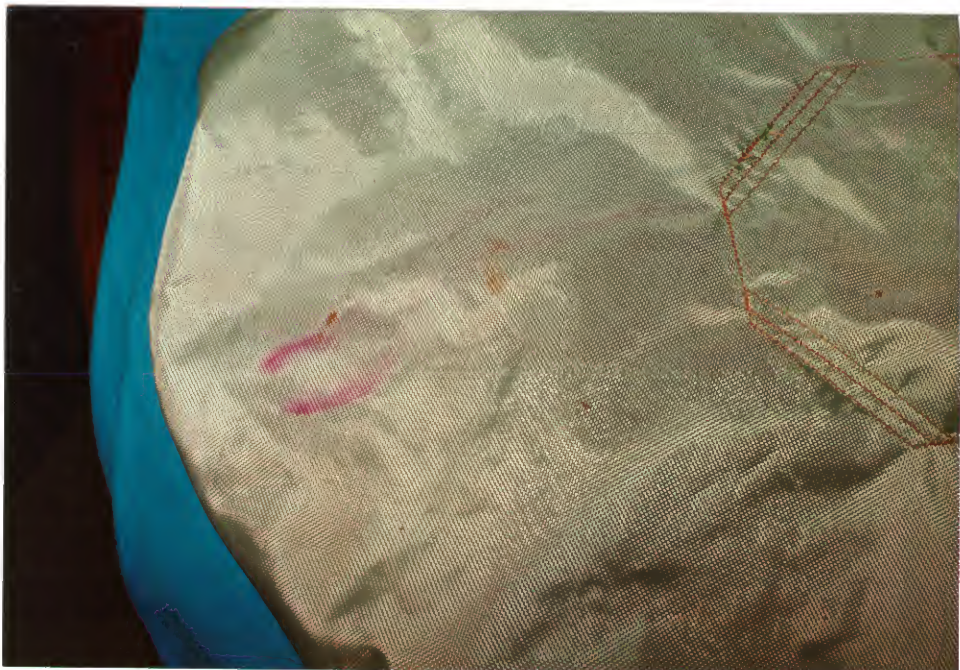
The driver's initial contact with the deployed air bag was located at the 8:45 - 10 o'clock position of the bag. A lipstick transfer was located 9 - 11.25" left of center and .25 - 1.75" below the horizontal centerline of the air bag. A faint continuation of the lipstick transfer extended to the center (tether reinforcement) area of the bag. An oblong makeup deposit was located 6.5 - 12.25" left of center which extended .25 - 3.0" above the horizontal centerline. There was also a faint crossing pattern that appeared to be a lipstick transfer that was centered 8.25" left and 4.75" above the horizontal centerline. This transfer probably occurred post-crash as the bag deflated. Blood spatters were noted to both sides of the air bag as the driver remained in her vehicle following impact.

Lip Stick Transfer On The Air Bag At The 8:30 Position

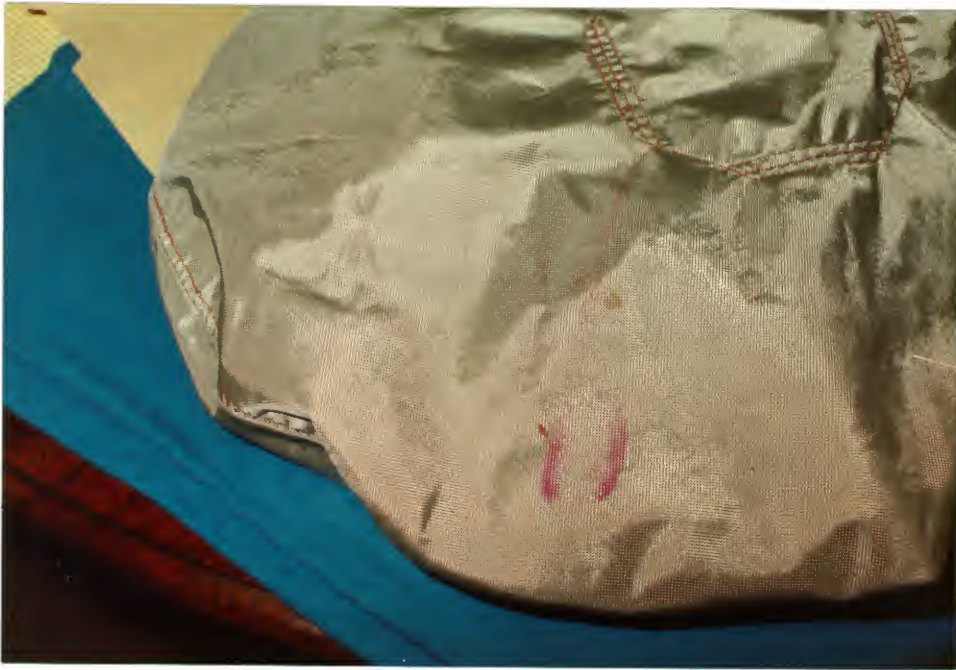
Lip Stick Transfers Fade At The Tether Reinforcement Stitching

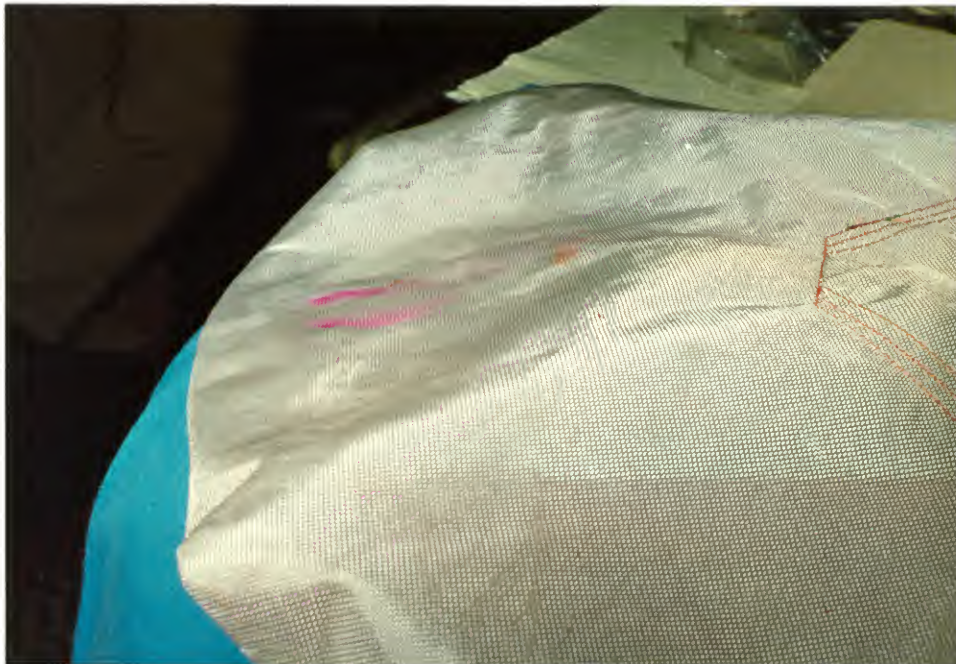
Makeup Transfers Above The Lip Stick

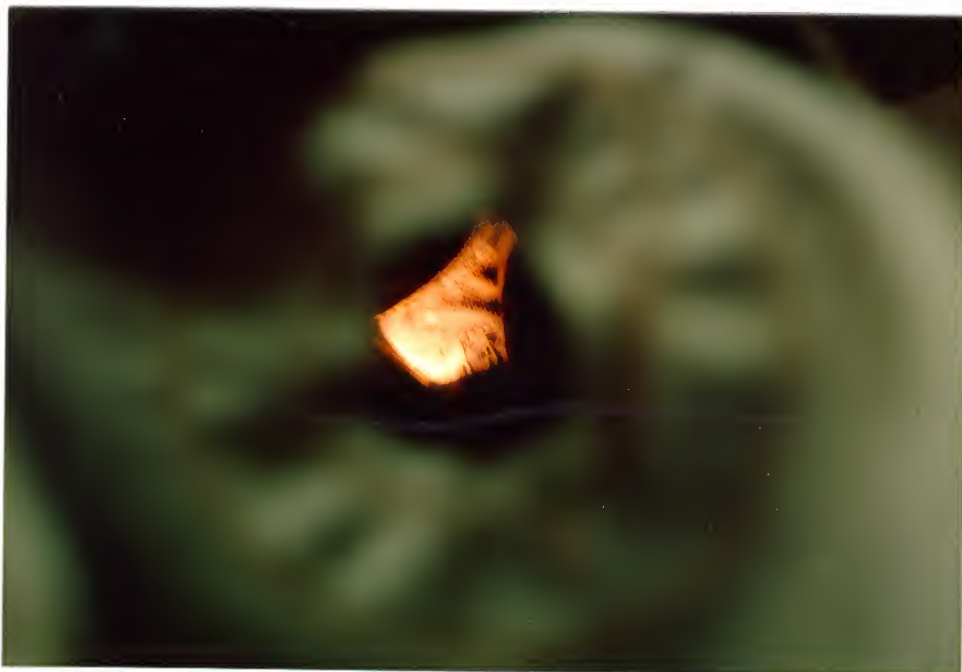
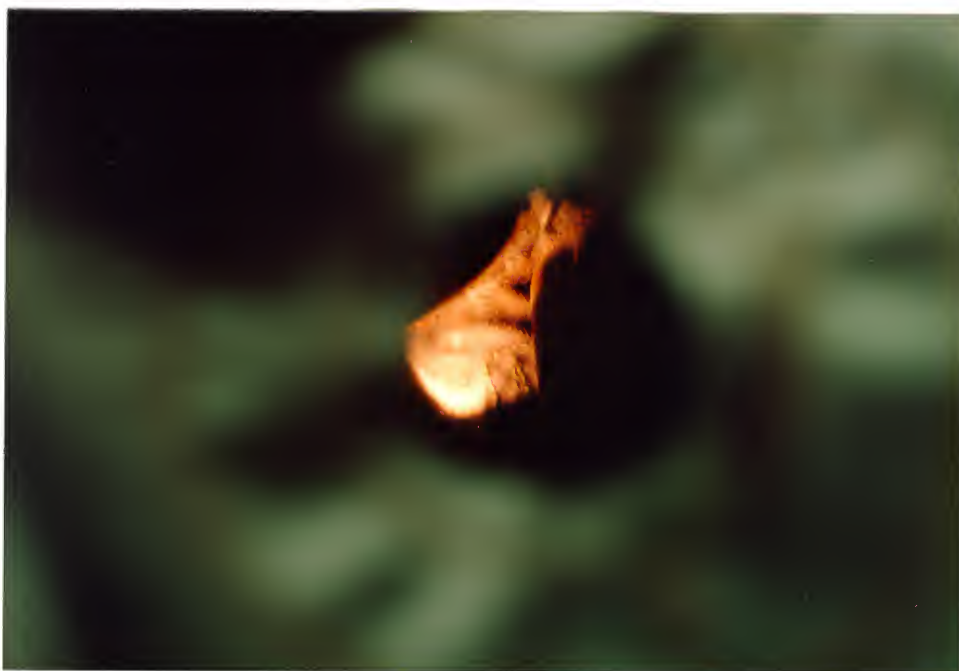
Calspan conducted an on-site inspection of the module assembly on ~~XXXXXX~~, and verified the location of the facial transfers and internal generant residue deposit. The internal generant residue deposit was located at the 6:30 - 7:30 o'clock position on the neoprene lining adjacent to the steel inflator unit. The residue also covered 3 orange stitches that the husband initially reported as burned away. There was also a small deposit of residue on the filtering screen at the 4 o'clock position. No screen material at the inflator ports was burned or deformed.

The filter screen of the inflator port at the 4 o'clock position contained a deposit of generant residue; however, the filter was intact with no visible (exterior) burn-through. The internal deposits were located approximately 45 - 75° counterclockwise or below the husband's original reported positions.

Generant Residue Deposits On The Inside Surface Of The Air Bag
Adjacent To The Inflator Assembly At The 6:30 - 7:30 O'Clock Position

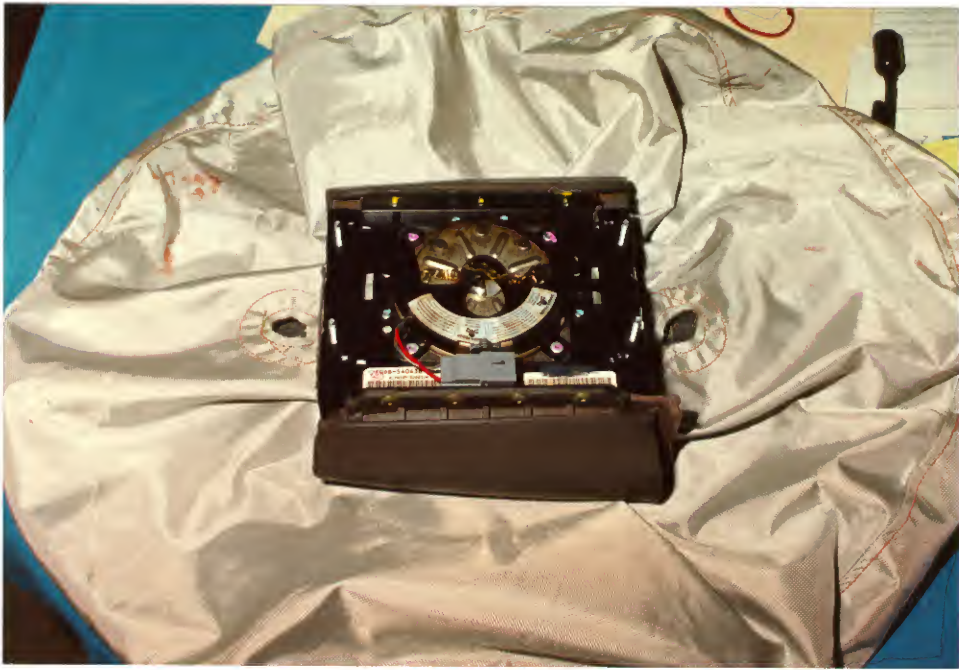
Posterior View Of The Air Bag And Inflator Assembly

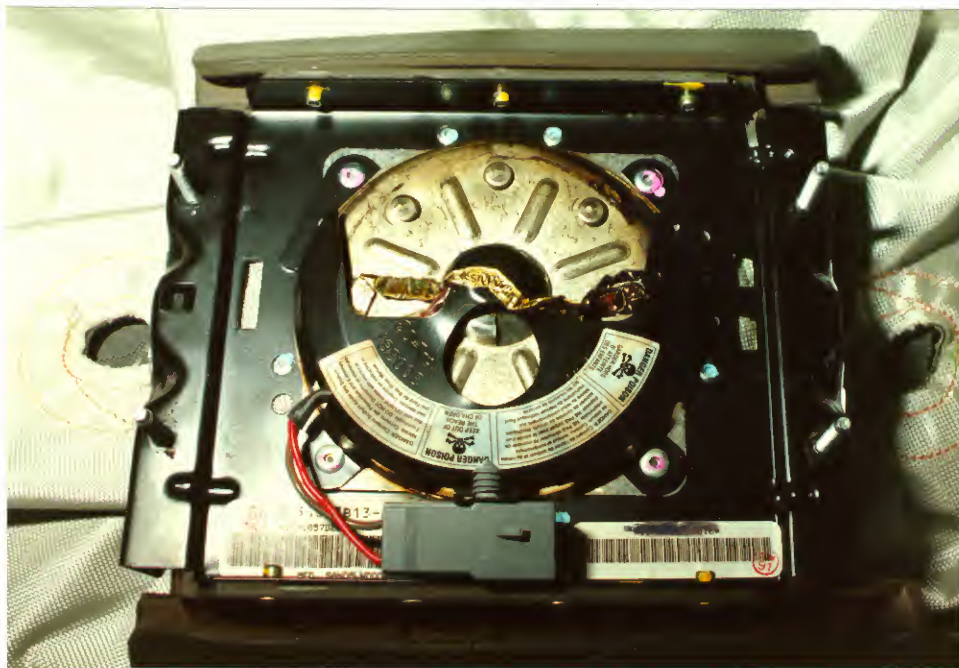
Close Up View Of The Inflator

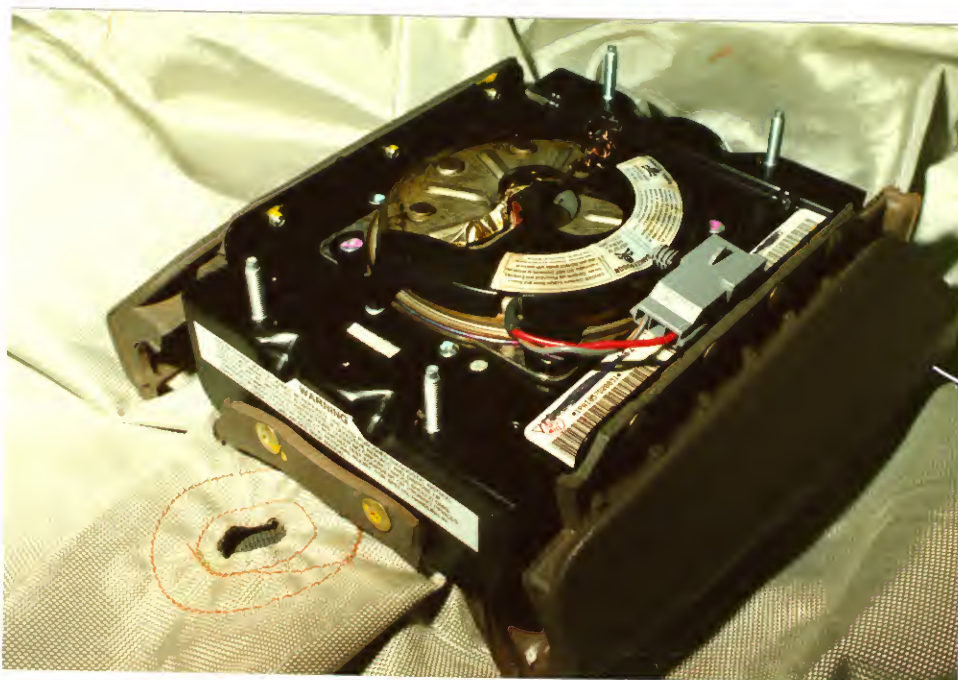
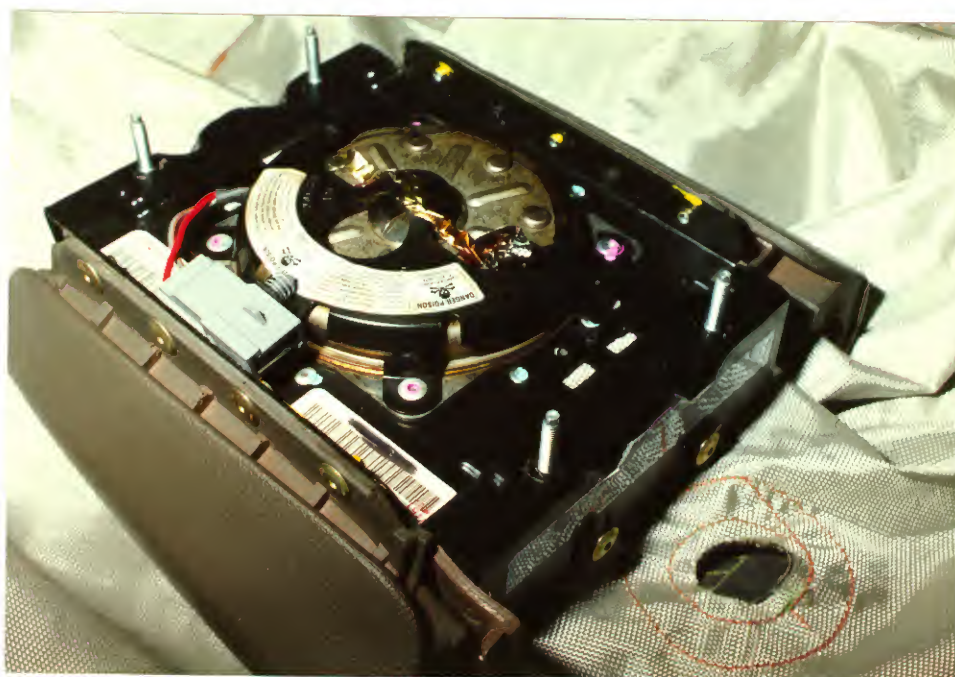
Offset Views Of The Inflator Assembly

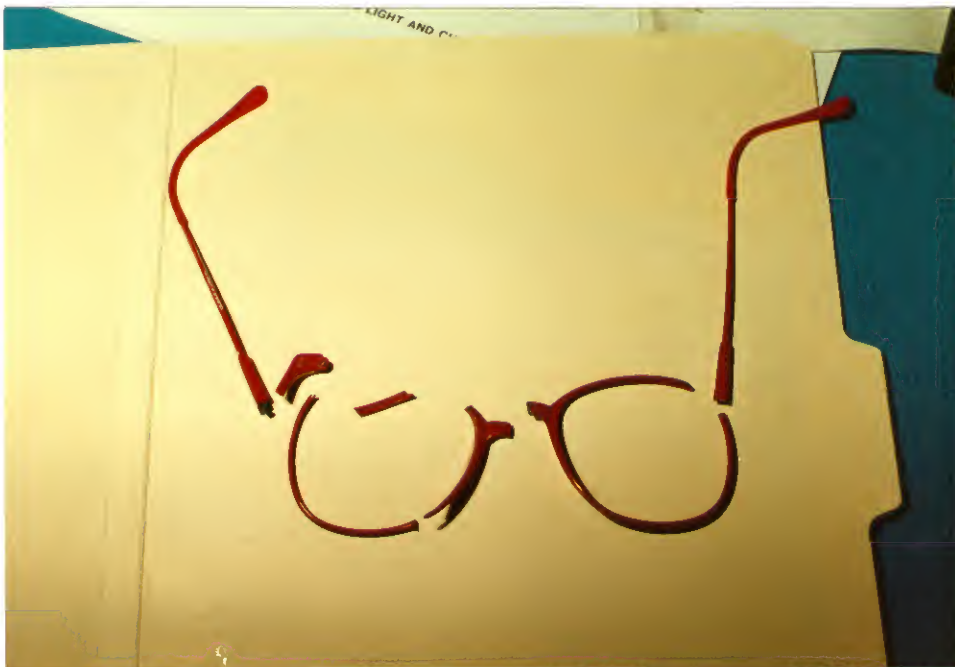
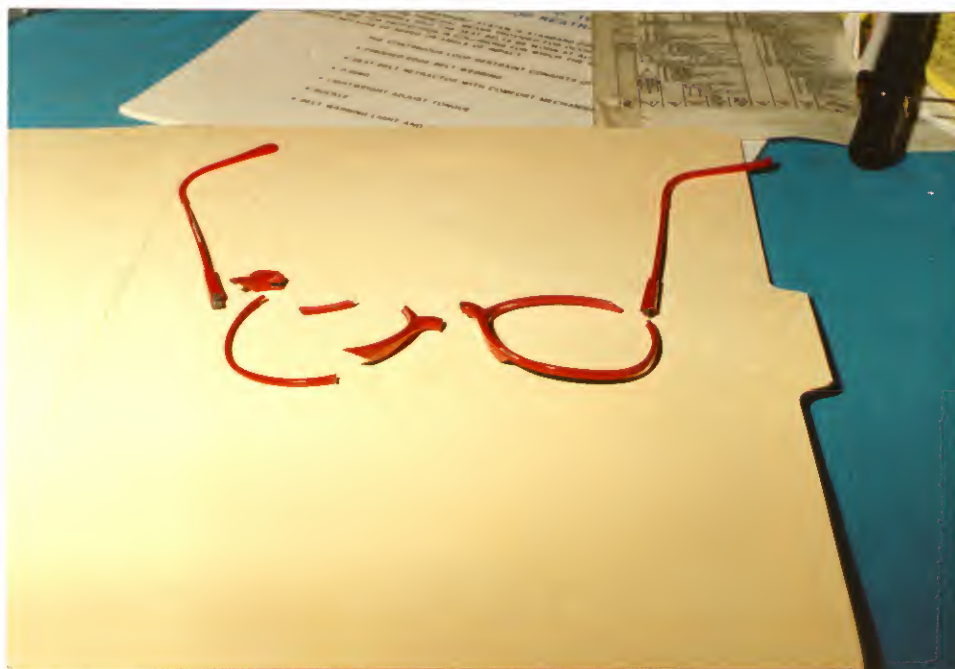
Fractured Driver's Eyeglass Frames, Graphite Material

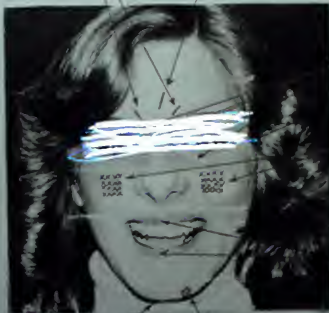
Forehead lacerations were surrounded by abrasion (AIS-1), air bag contact

2 semilunar .5" lacerations at the medial end of the eyebrows

2 cm vertical laceration of the mid forehead area (AIS-1), eyeglass frames/air bag contact

Hematoma and contusion of both upper and lower eyelids (AIS-1), eyeglass lenses/air bag contact

Abrasions of both cheeks with surrounding hematomas (AIS-1), air bag contact

Swelling of the upper and lower lips

Neck pain, arthritic condition

1 cm abrasion of the neck (AIS-1), air bag contact

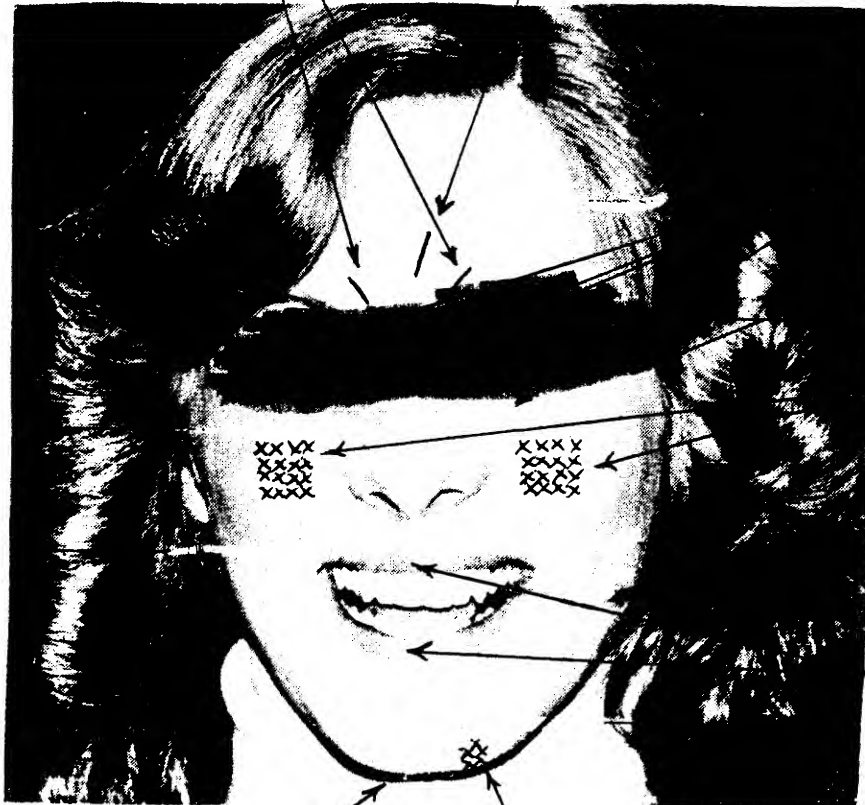
Air Bag Driver Injury Mannequin

Forehead lacerations were
surrounded by abrasion
(AIS-1), air bag contact

2 semilunar .5" lacerations
at the medial end of the
eyebrows

2 cm vertical laceration of the
mid forehead area (AIS-1), eyeglass
frames/air bag contact

Hematoma and
contusion of both
upper and lower
eyelids (AIS-1),
eyeglass lenses/
air bag contact

Abrasions of both
cheeks with
surrounding
hematoma (AIS-1),
air bag contact

Swelling of the
upper and lower
lips

Neck pain,
arthritic condition

1 cm abrasion of the
chin (AIS-1), air bag
contact

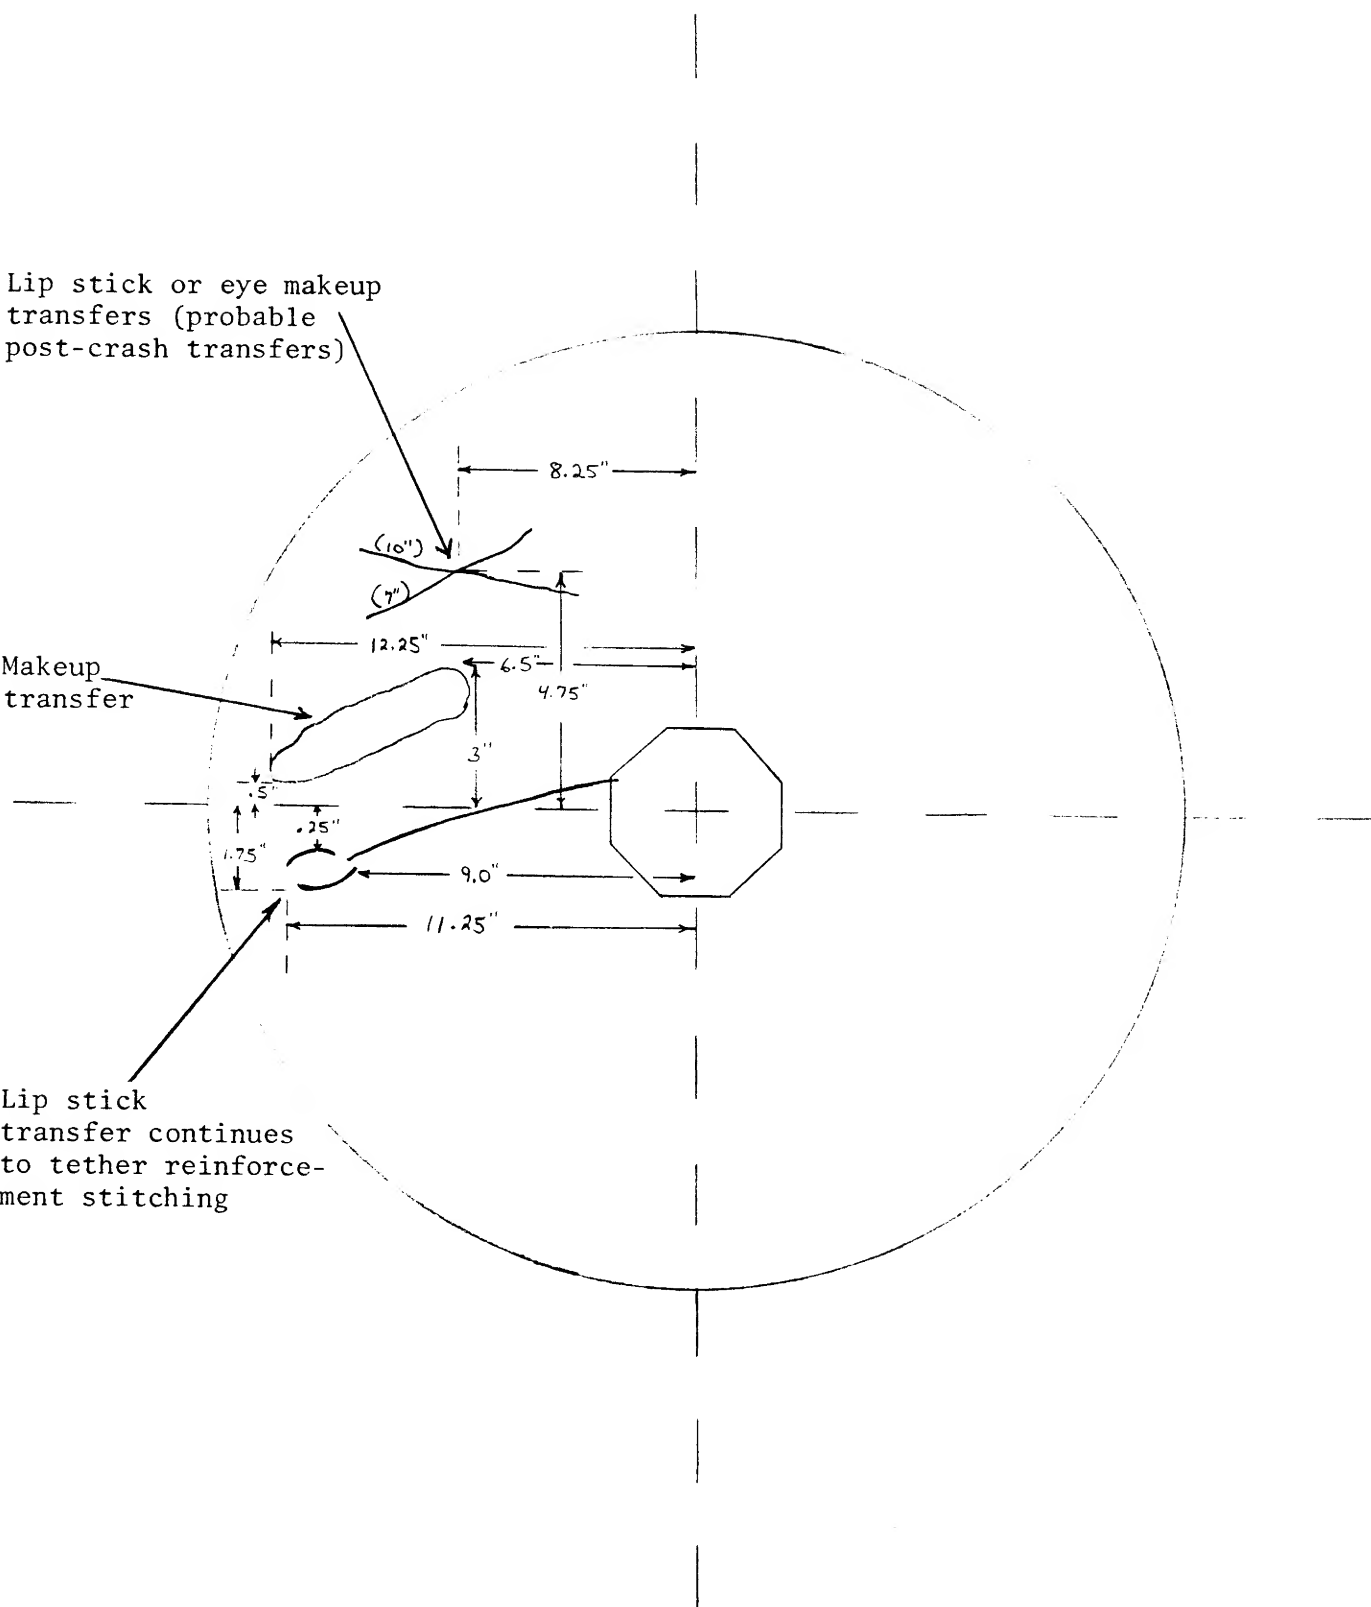
Air Bag Contact Schematic

Lip stick or eye makeup
transfers (probable
post-crash transfers)

Makeup
transfer

Lip stick
transfer continues
to tether reinforce-
ment stitching
